HARPENDEN SOCIETY / HARPENDEN URBAN DESIGN GROUP

Upper Lea Valley Group's 2nd Interim Report

CENTRAL AREA STUDY

MARCH 1972

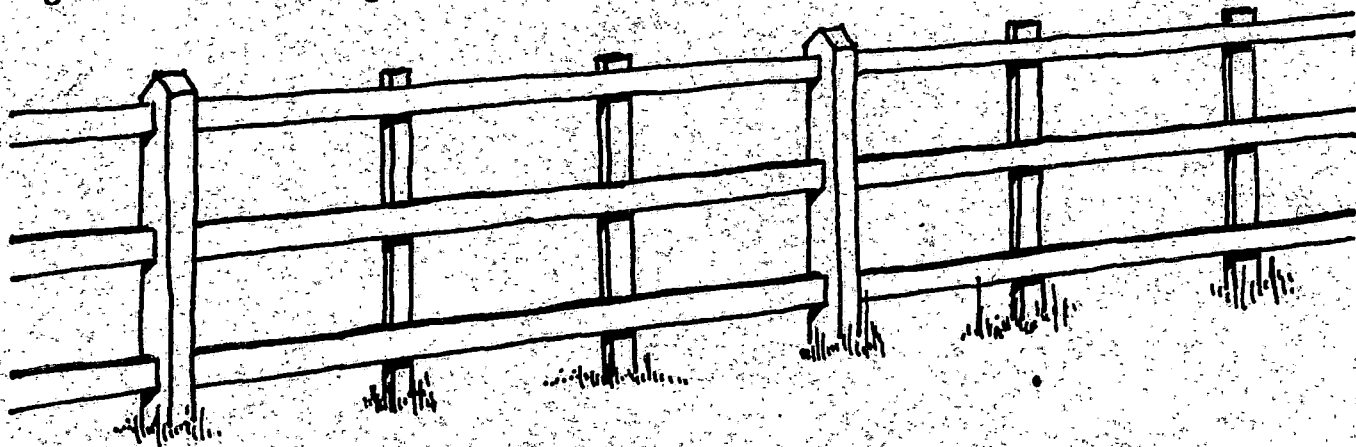
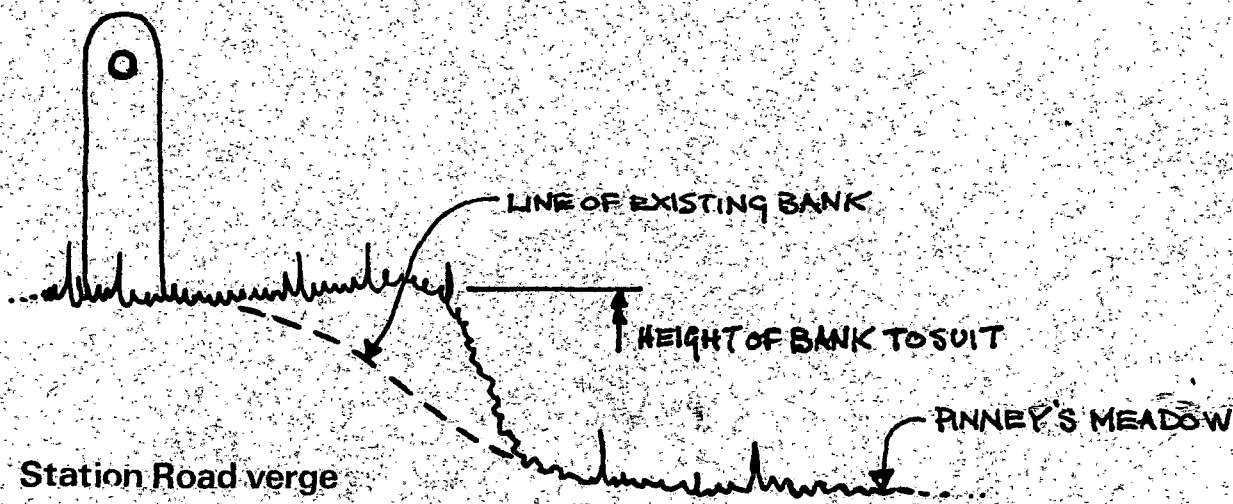
Fig 2 Timber fencing

At present the hedging on the east and south boundaries is supplemented by posts and barbed wire fencing which is in a poor state of repair. This would be a good place to introduce the type of wooden fencing illustrated in Figure 2.
